Fracture of a Marine Gear (A)

INVESTIGATION OF FAILURE OF  
LOW SPEED GEAR WHEEL  
DURING FABRICATION

Metallurgical Report No. 728

INVESTIGATION OF FAILURE OF  
LOW SPEED GEAR WHEEL DURING FABRICATION

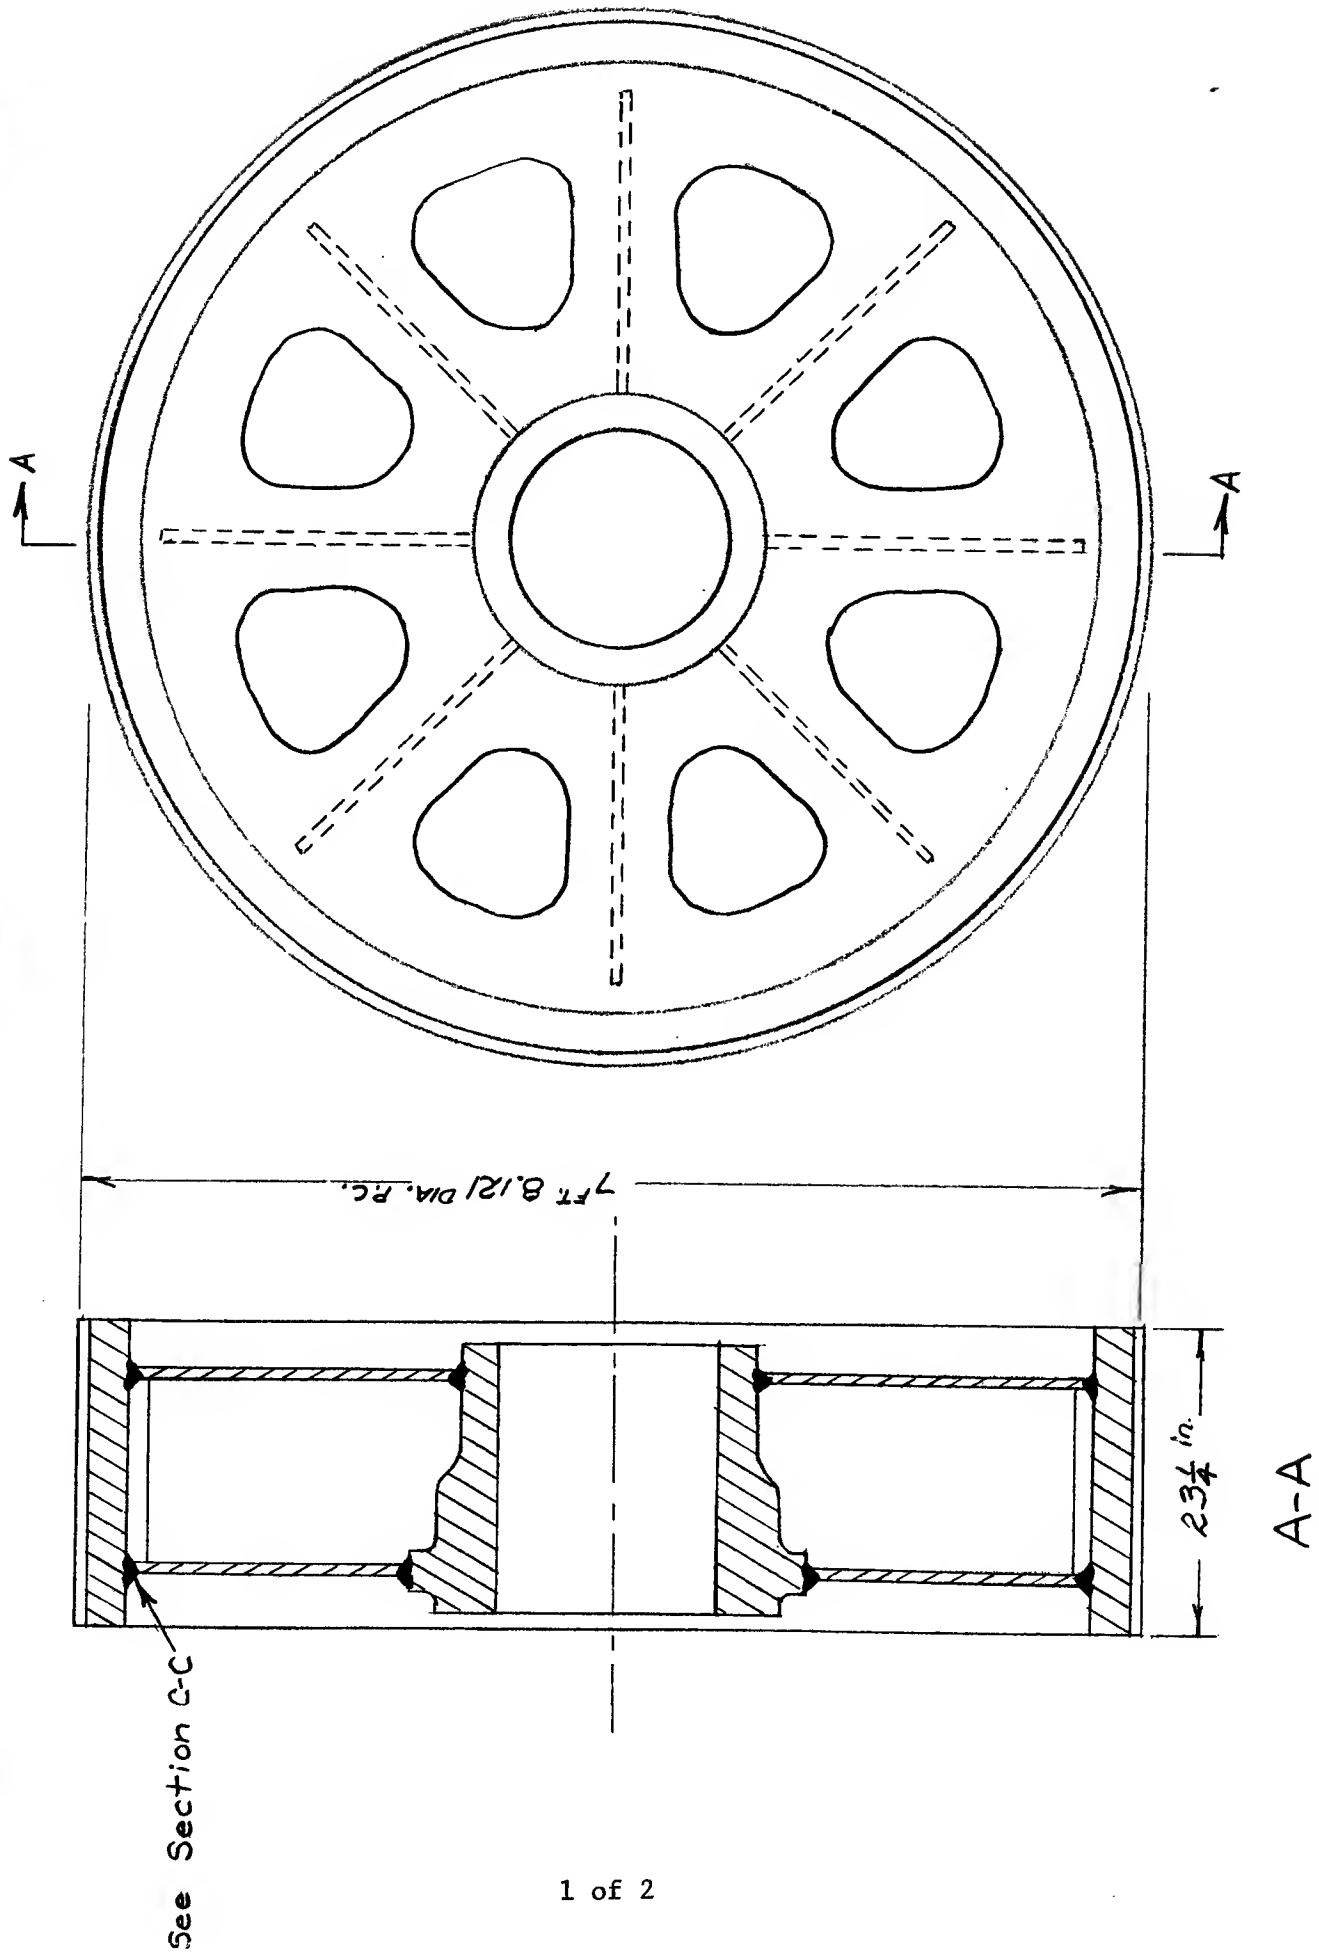
Exhibit 2. Casewriter's sketch of a typical sector of gear showing location and direction of cracks before weld was machined off and gear "exploded". Photographs of cracks after the weld was machined off are shown in Exhibit 4.

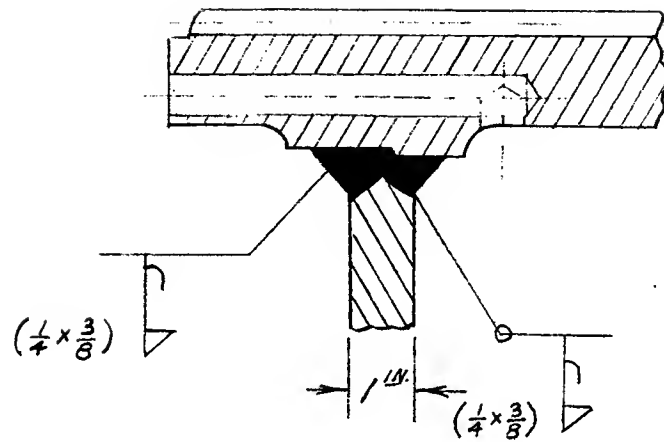
SECTION C-C

Slow speed gear wheel similar in type to the one that failed in 1955.

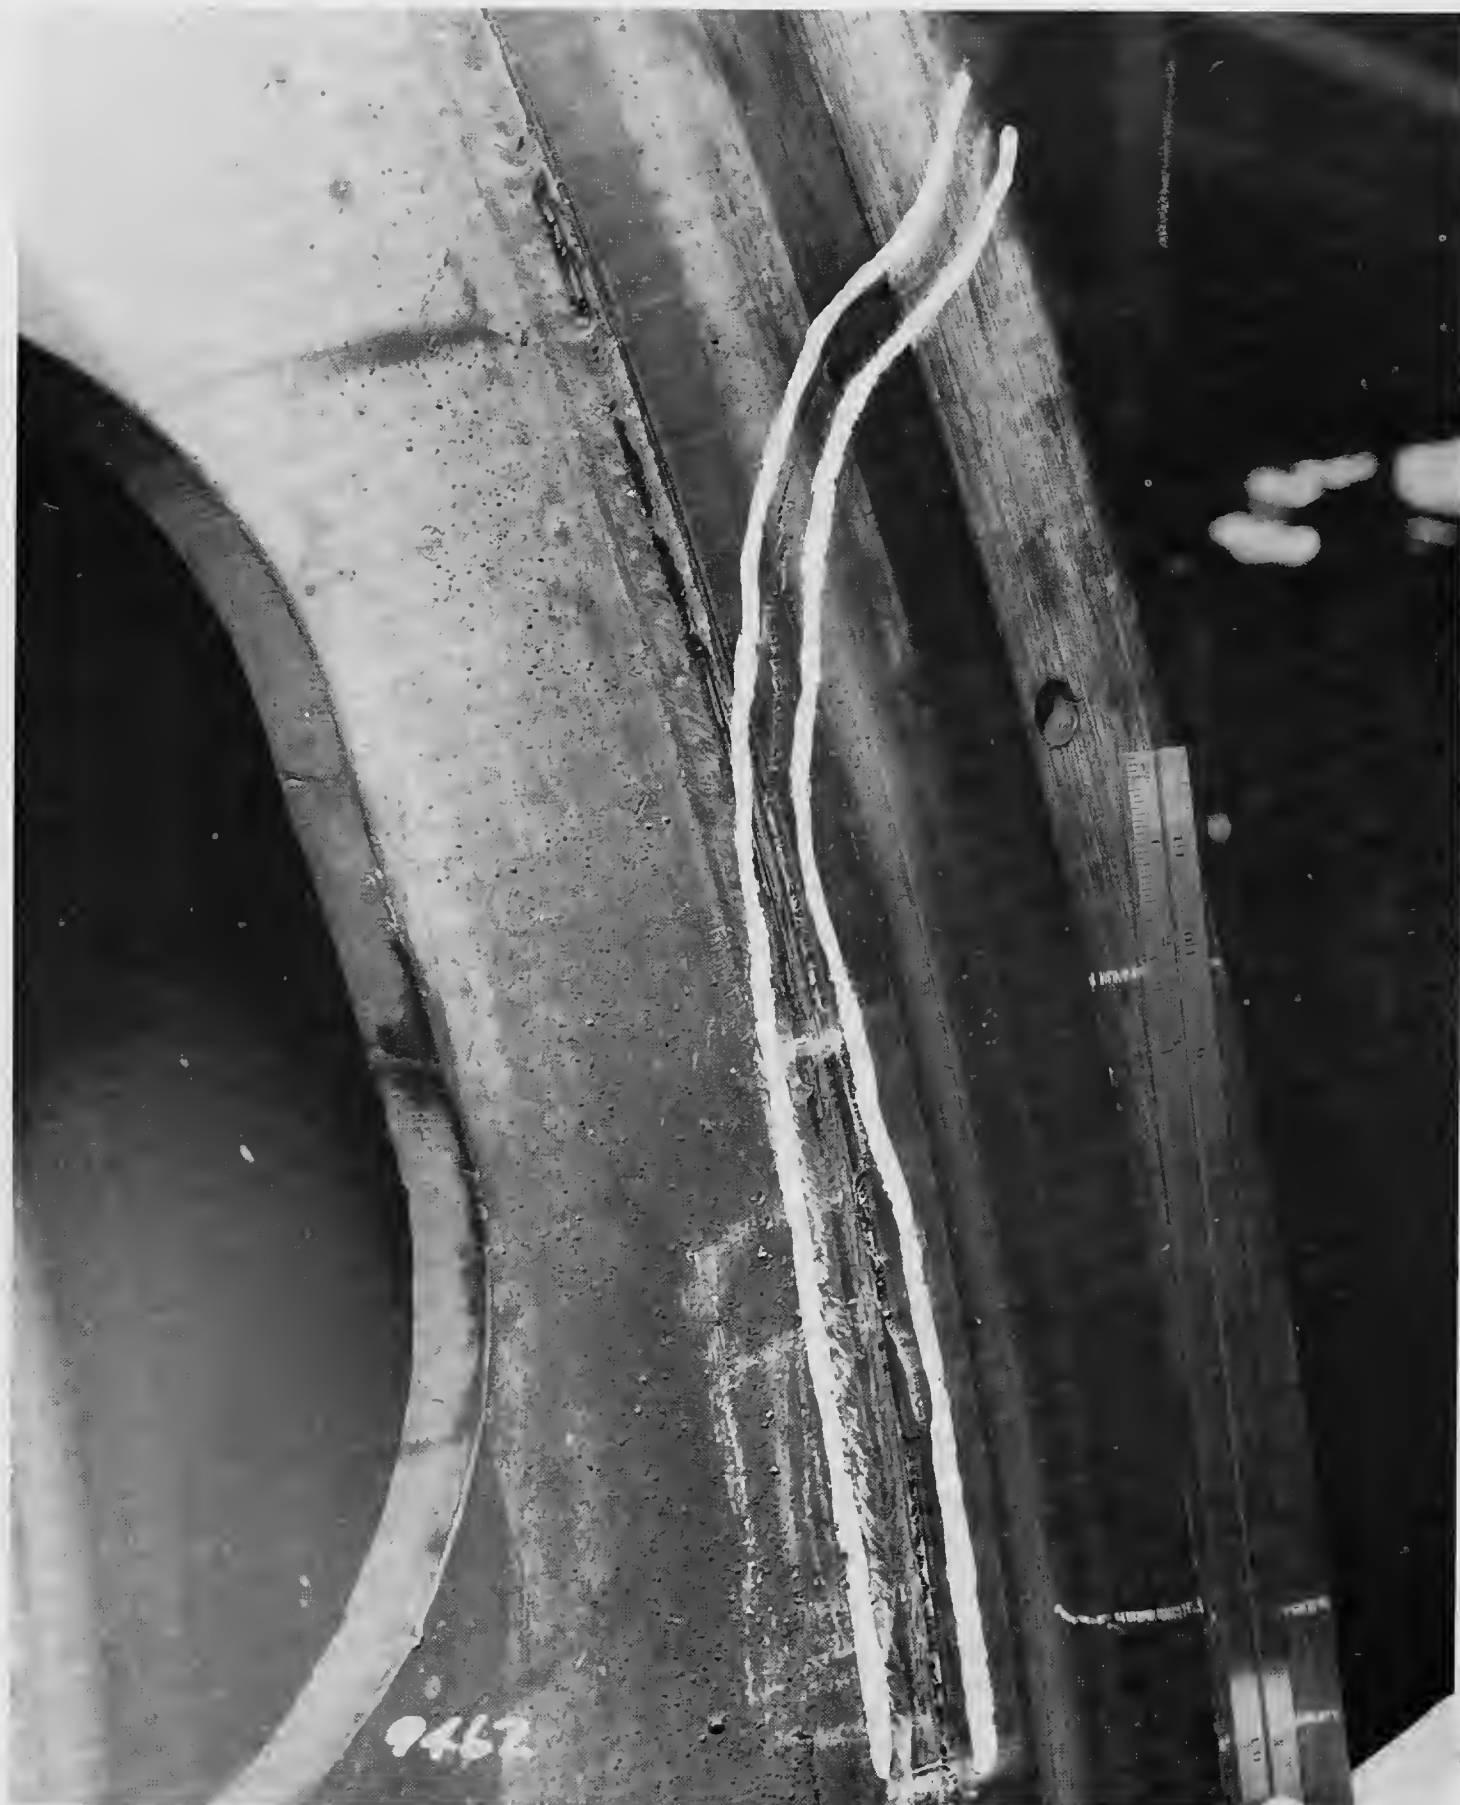
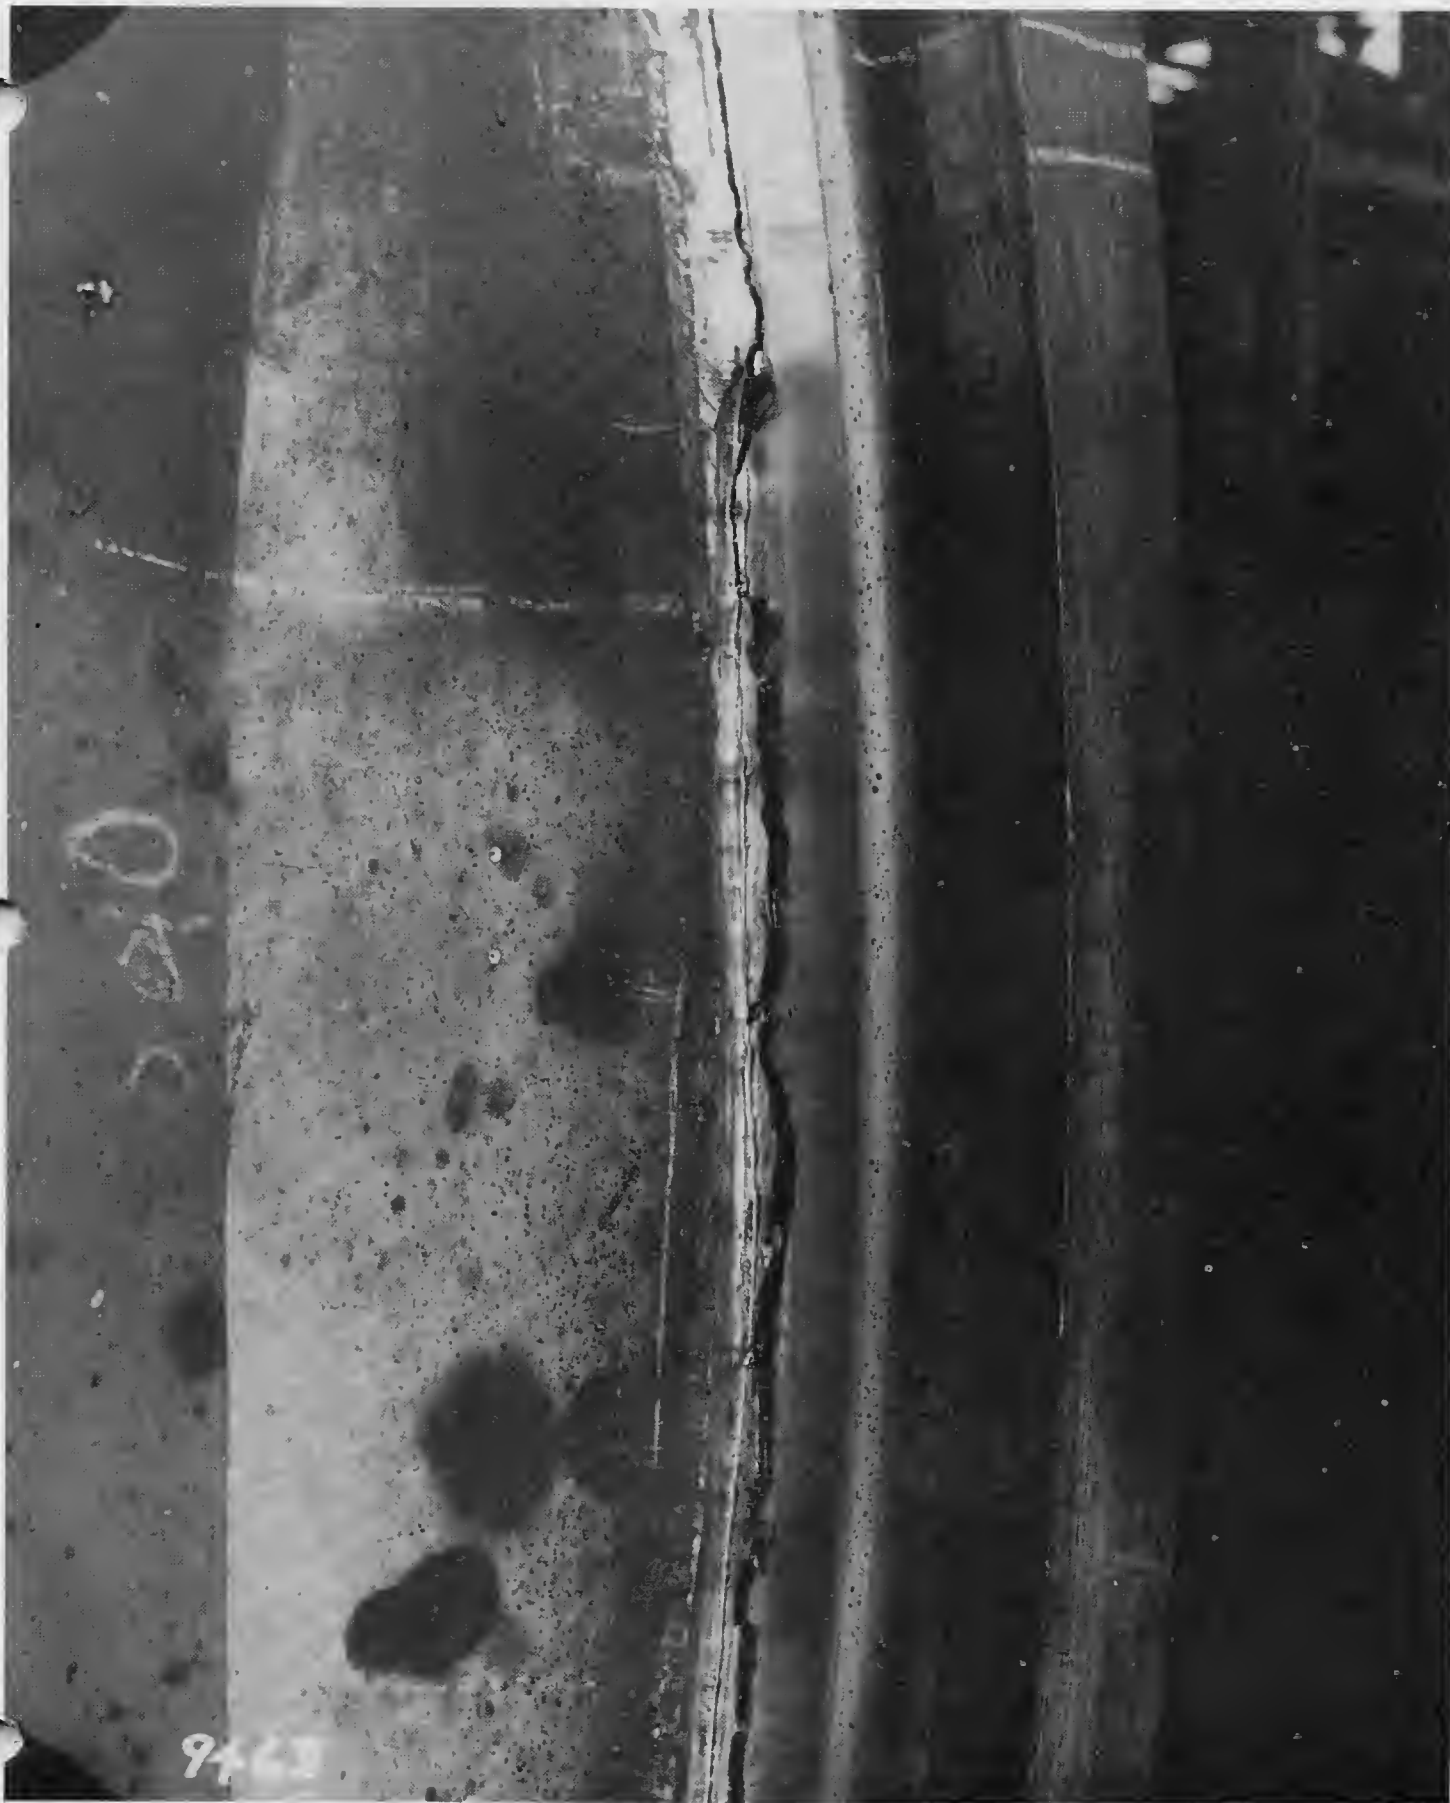
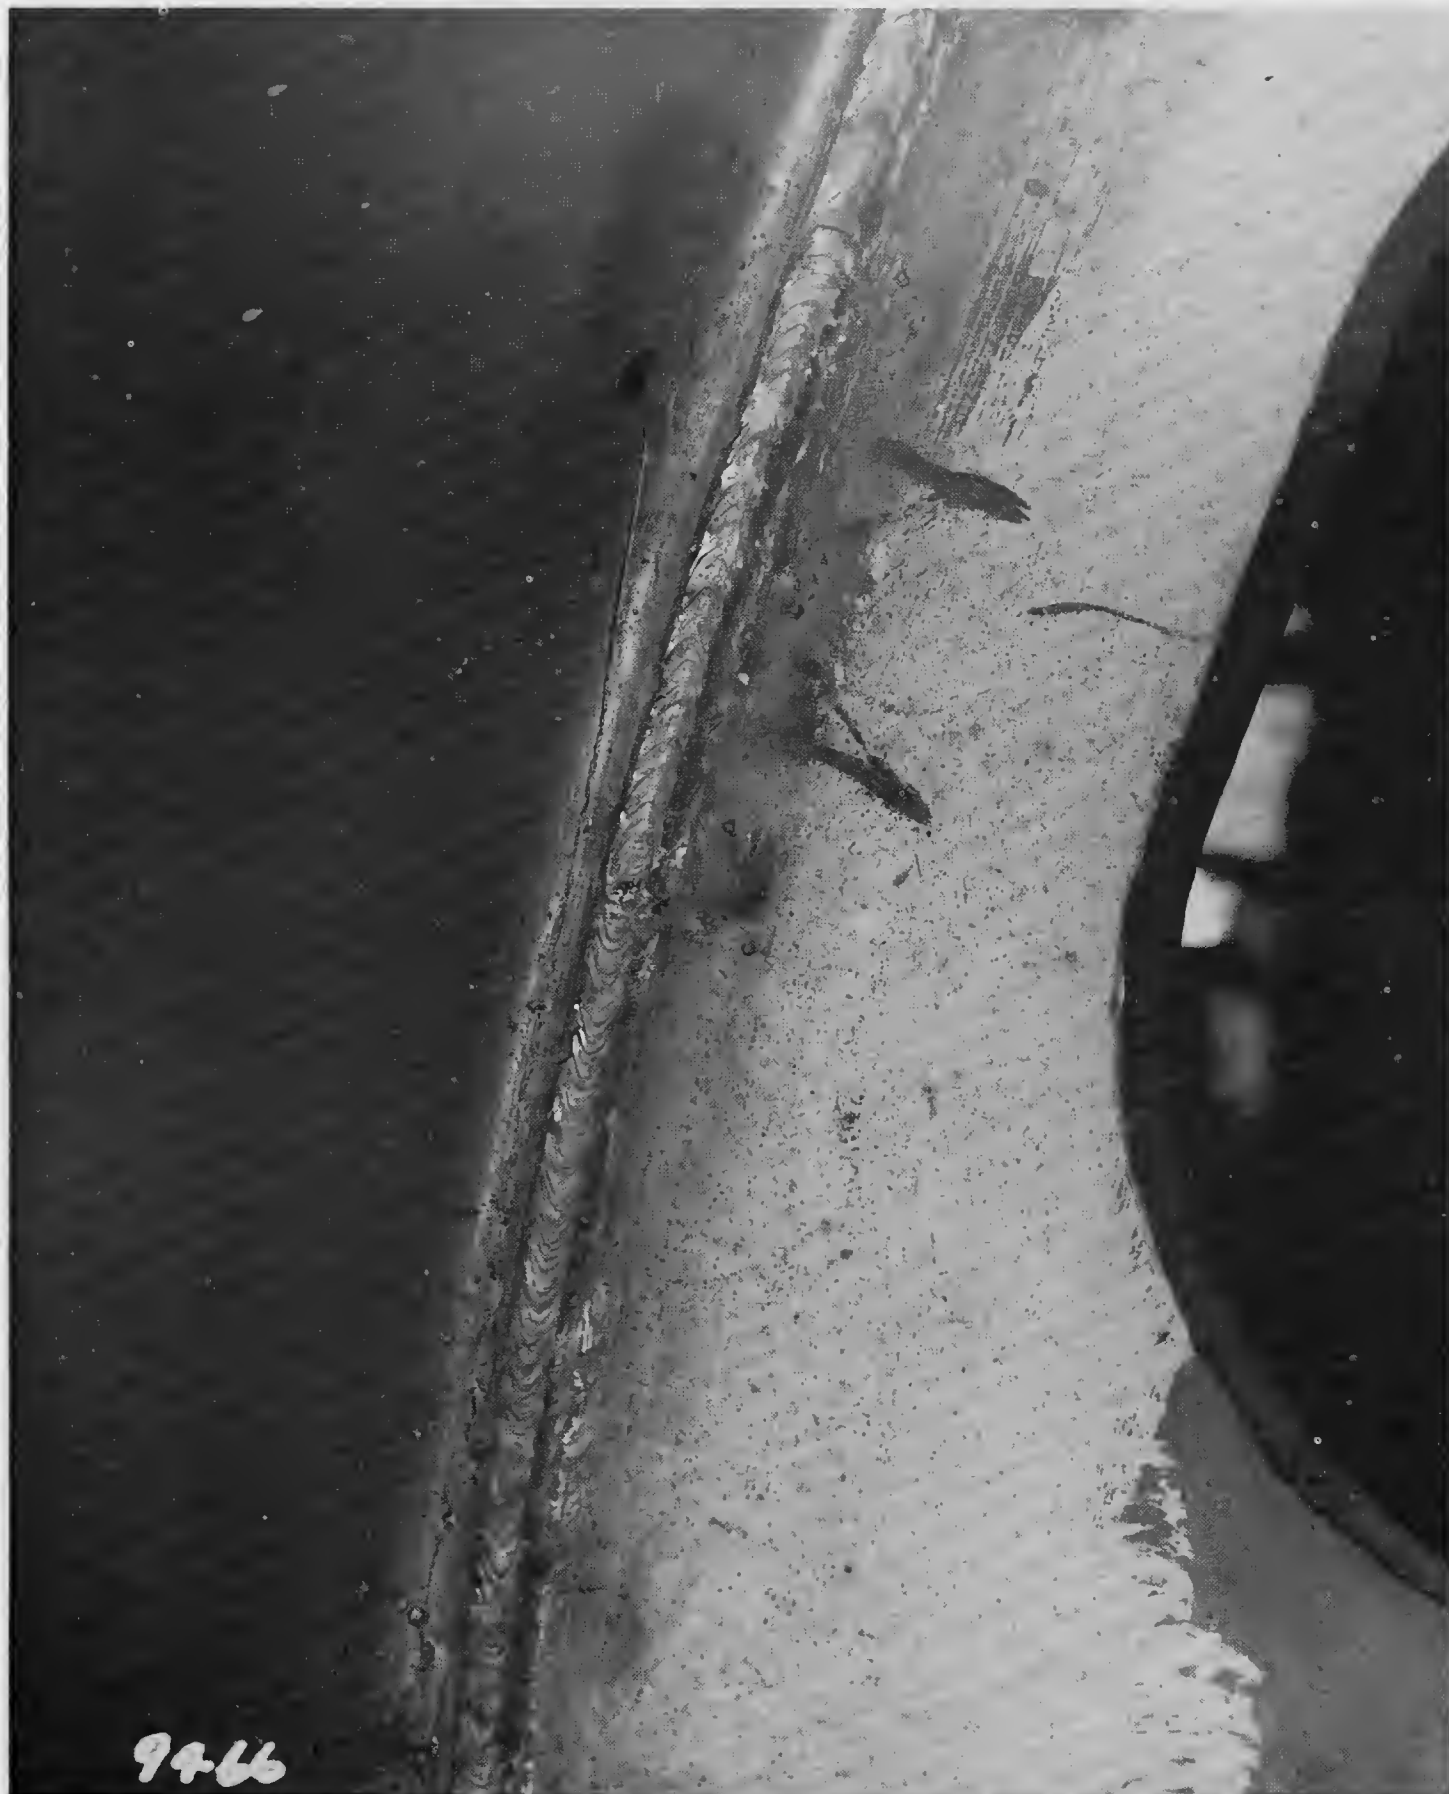
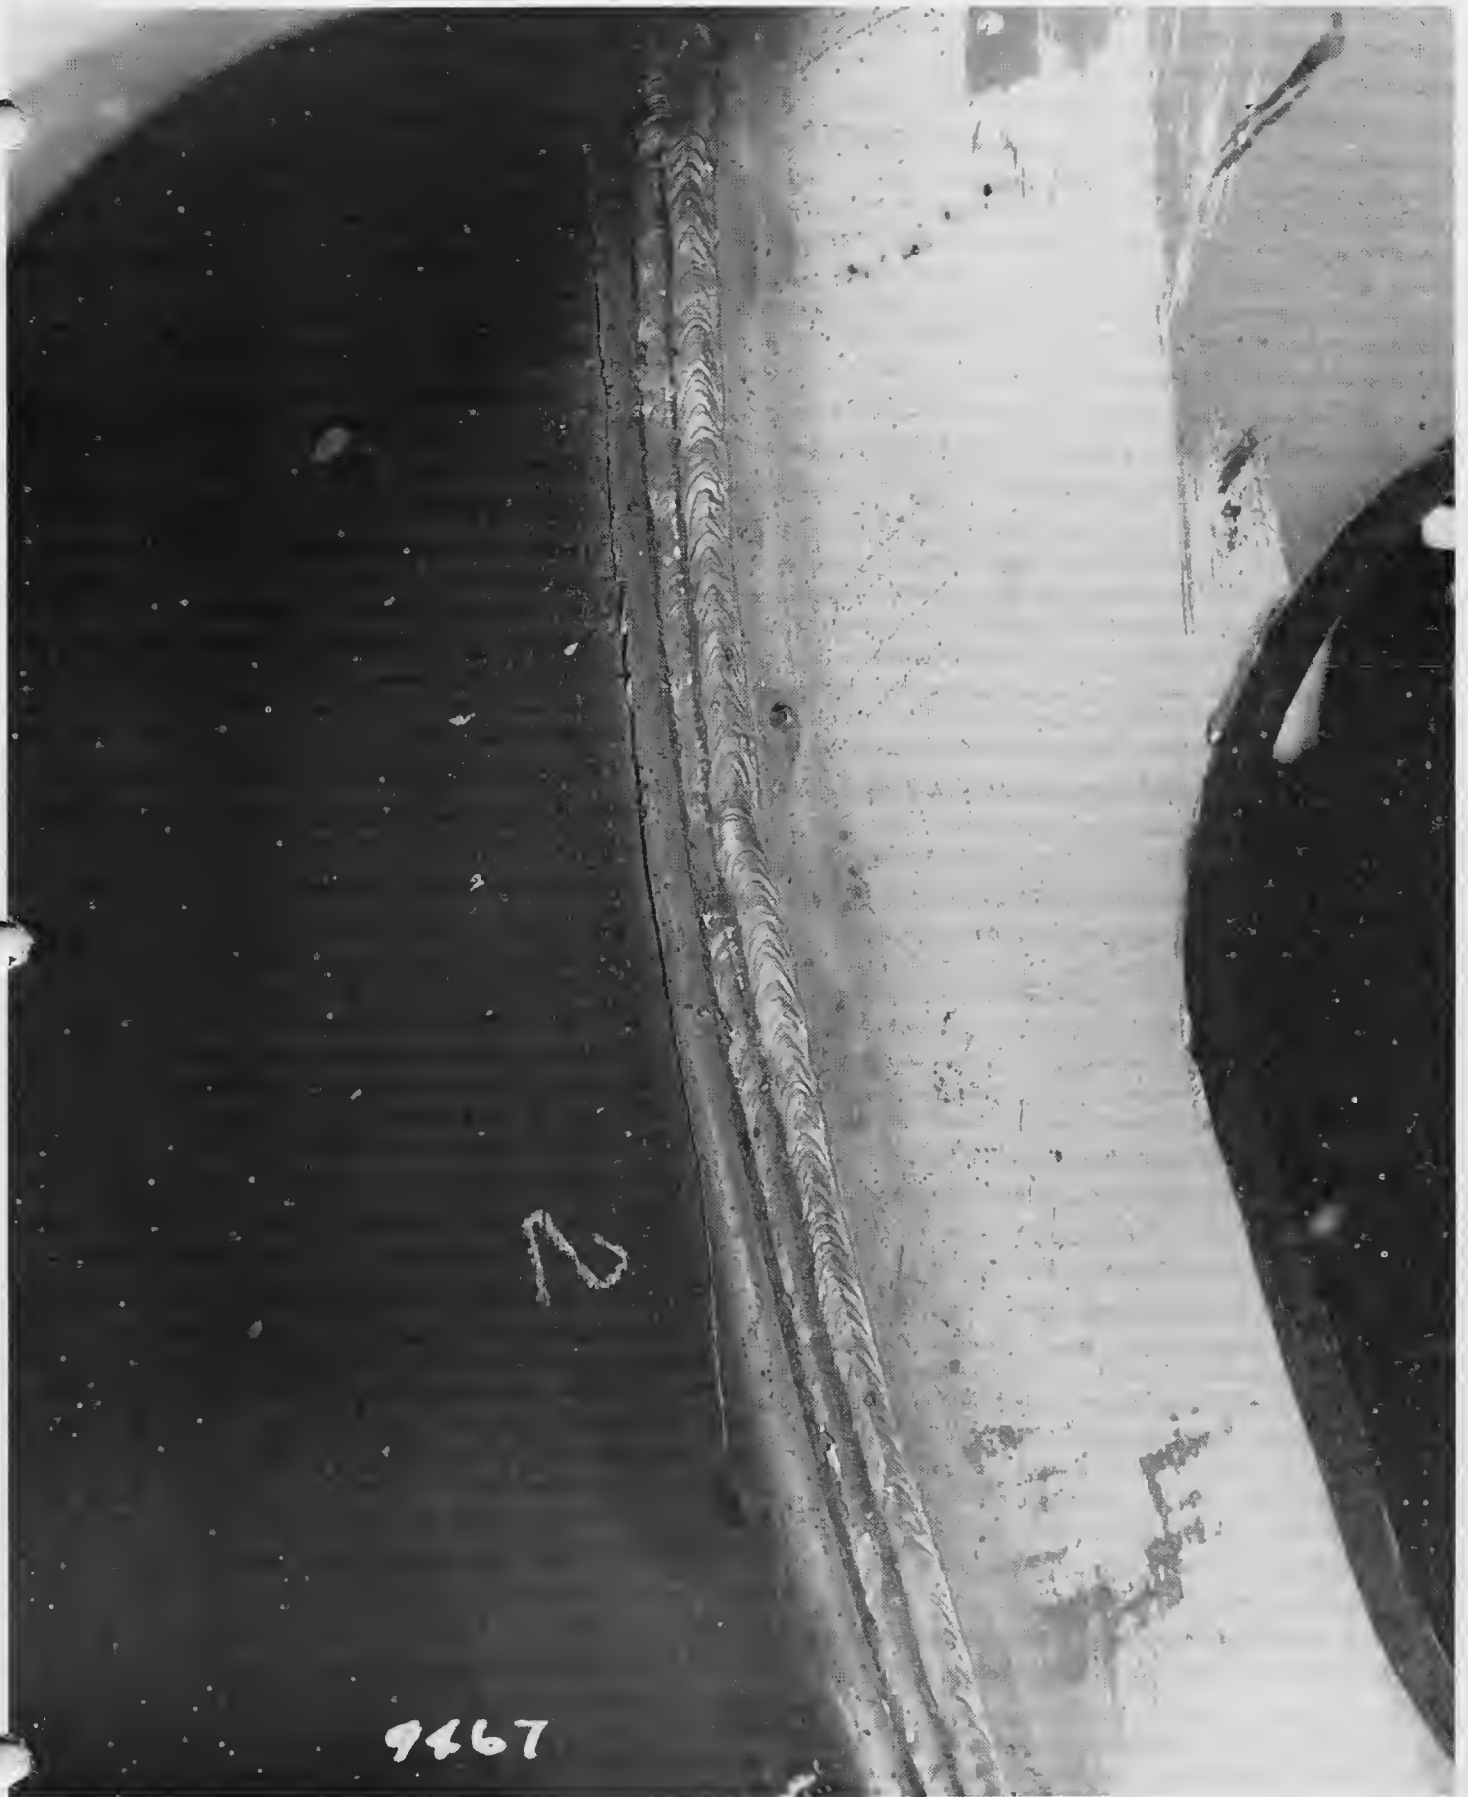
The extent of the main crack over a total distance of 96" on the circumference is shown in the following photographs:

1. Photograph 9462 - Crack originating at weld fusion line and extending through rim thickness on edge to O.D.
2. Photograph 9463 - Fusion line crack at widest section - approximately 5/32" wide.

3. Photograph 9464 - Crack at other end from that shown in Photograph 9462 ending in oil drain hole. Note separate crack in gear rim slightly below crack end.
4. Photograph 9466 - View showing end of crack from I.D. of rim.
5. Photograph 9467 - View showing other end of crack on I.D. of rim.
6. Photograph 9476 - Extent of cracks as revealed by magnetic particle inspection after failure. Section A covers extent of crack shown in the above photographs. Section B contains both undercut and cracking at fusion line of weld. Sections C, D, E, F, G and H are additional cracked areas in fusion line as shown by magnetic particle inspection.

3. When making welds on joints involving alloy steel wherever possible use a bead sequence which will allow last bead to be made on weld deposit or on mild steel. This will allow overlaying beads to anneal underlying weld on alloy material reducing the hardness in the heat affected zone.

4. Avoid undercut along weld edge which can act as a notch to "trigger" cracking.
5. On subsequent gear wheels if cracking is encountered, stress relieve prior to removal of defects to avoid propagation of cracks.
